## Pictorial review

# Sacral insufficiency fracture

<sup>1</sup>S P BLAKE, FFR-RCSI, FRCR and <sup>2</sup>A M CONNORS, FFR-RCSI

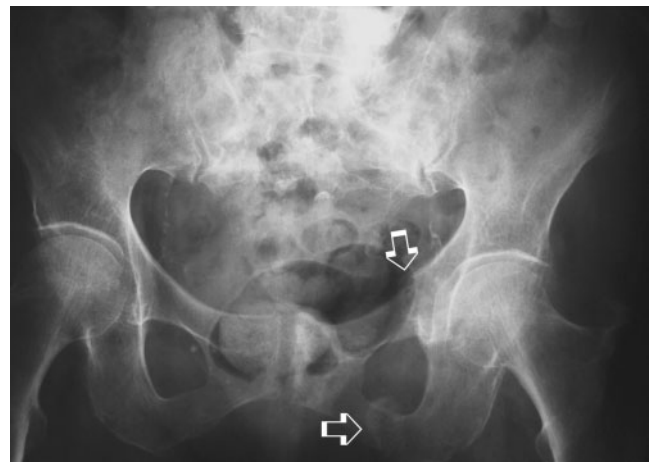
**Figure 1.** A 79-year-old female presenting with recurrent minor falls and right hip pain. Plain film of pelvis demonstrating fractures of superior and inferior pubic rami on the left side. The sacrum shows generalized sclerosis. Note is also made of sclerosis at the left L5/S1 facet joint secondary to degenerative change. CT (not shown) confirmed bilateral sacral fractures and healing fractures of the left pubic rami.

Plain radiographs of the pelvis, sacrum or lumbar spine are often performed as the first screening test and sclerotic bands, cortical disruptions and even visible fracture lines may be seen in the sacral ala (Figures 1 and 2b) [1]. However, the sacrum is often obscured by bowel gas and the subtle findings are not usually identifiable or diagnostic (Figures 2a and 3a) on plain films or may be misleading [1, 3–5]. Other pelvic insufficiency fractures often co-exist (Figure 1) [1–5] and these may have an aggressive appearance mimicking malignancy, depending on the degree of bone healing [1].

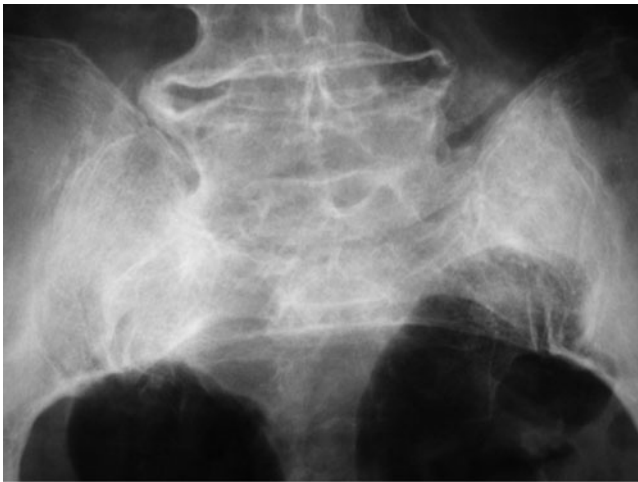
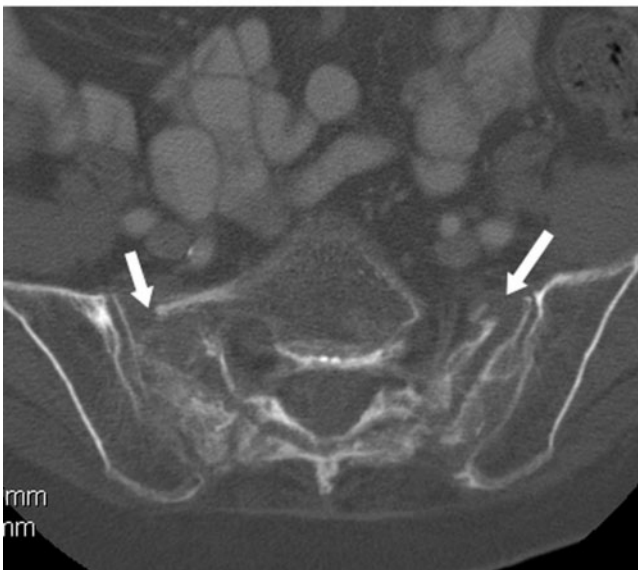
**Figure 3.** A 76-year-old female with rheumatoid arthritis and new onset of severe low back pain. She also had weight loss, anorexia and possible left iliac fossa mass and malignancy was strongly suspected. (a) Plain radiograph fails to demonstrate significant abnormality. (b) Axial  $T_1$  weighted MR image (repetition time 700/echo time 20) demonstrating low signal intensity in both sacral alae. Because of the suspicion of malignancy, intravenous gadolinium chelate was given. (c) The post-contrast  $T_1$  weighted axial MR image (repetition time 700/echo time 20) shows enhancement through the sacral ala, with linear defects representing fracture lines. (d) Posterior view of isotope bone scan shows an asymmetric H-shaped appearance of bilateral sacral insufficiency fracture, the uptake being more marked in the right sacral ala (arrow). (e) CT scan through the sacrum shows no space-occupying lesion and confirms the bilateral insufficiency fracture (arrows).

of the fracture (Figure 4b) and  $T_2$  weighted images can also be useful (Figure 4c), particularly if fat suppression is used [7]. If intravenous gadolinium chelate is given the fracture line may also be demonstrated (Figures 3c and 5b), although this is usually not necessary [7].

This is a sensitive technique for suspected insufficiency fractures of the sacrum. The classic "H" pattern (Figures 3d, 4d and 5d) is considered diagnostic in the right clinical setting and is produced when there are fractures of both sacral alae and a horizontal component involving the sacral body [1, 4, 5]. However the H-sign is often absent (Figure 2c) [3, 7] and if there are other pelvic insufficiency fractures, this may lead to misinterpretation as metastatic disease. In a meta-analysis by Finiels et al [3], the classical H-sign was documented in just 40%.

CT for this condition is accurate, efficient and specific [2, 4–7], although sometimes the findings are subtle and can be missed on the first reading [7]. The appearances on CT vary depending on the degree of healing. Most commonly there will be fracture lines, sclerotic lines, or both (Figures 2d–f, 3e, 4e and 5c) or areas of sclerosis within the sacral alae parallel to the sacroiliac joints [1, 3–5]. CT should show that the remainder of the trabeculae are intact, rather than destroyed by a space-occupying lesion. As such CT is helpful in confirming the diagnosis and excluding malignancy or osteomyelitis [1, 3, 5]. We
